ELECTROTECHNICAL TESTING INSTITUTE

TEST REPORT

Intercoms

ČSN EN 50486:2009, annex A.7

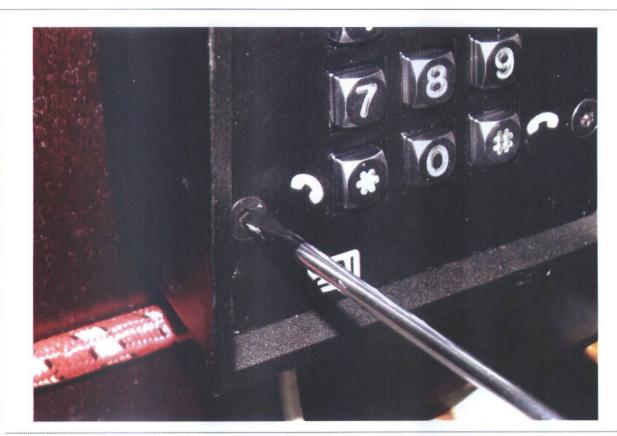
Fig. 5 - test 1 of intercom 2N® Helios IP Force 9151102CRW

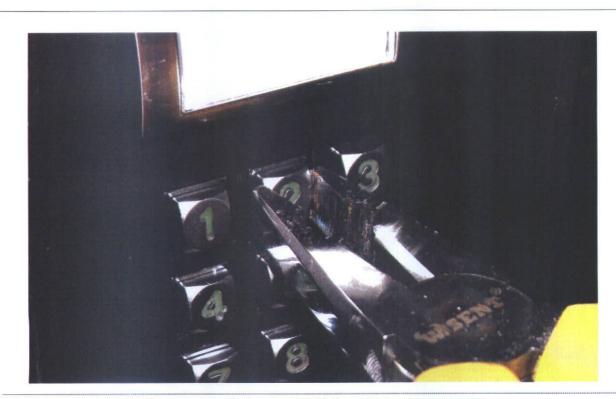
Fig. 6 - test 3 of intercom 2N® Helios IP Force 9151102CRW

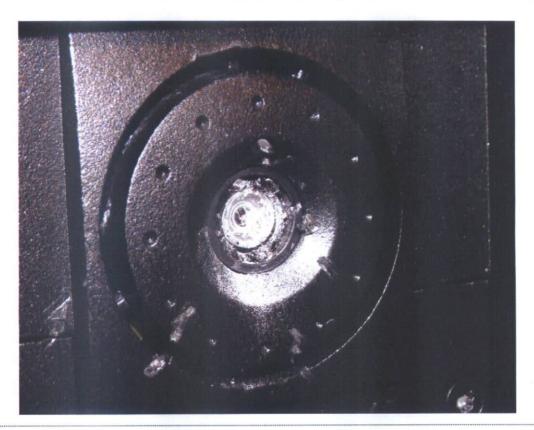
- a) intercom 2N® Helios IP Force 9151102CRW
 - test 1 the screws could not be unscrewed
 - test 2 N/A
 - test 3 no button was pulled or wrenched
 - test 4 no button was jammed
 - test 5 the glass cover of the camera was broken (the camera itself is still functional after the test), the enclosure surface was scratched, no button was damaged (the buttons are still functional after the test)
 - test 6 the bell button was partially scorched, no afterflame of any plastic part occurred, no button backlight was damaged
 - test 7 the drink did not penetrate into the intercom enclosure, the intercom function is not immediately disrupted

Fig. 7 - broken camera cover of intercom 2N® Helios IP Force 9151102CRW after test 5

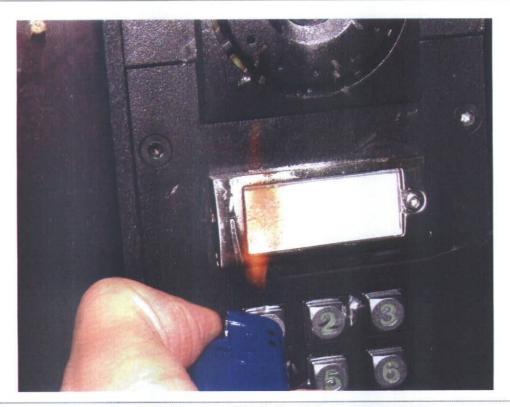
Fig. 8 - test 6 of intercom 2N® Helios IP Force 9151102CRW

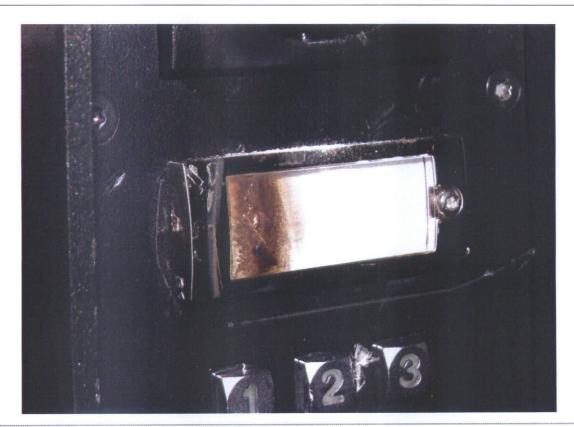
Fig. 9 - bell button of intercom 2N® Helios IP Force 9151102CRW after test 6

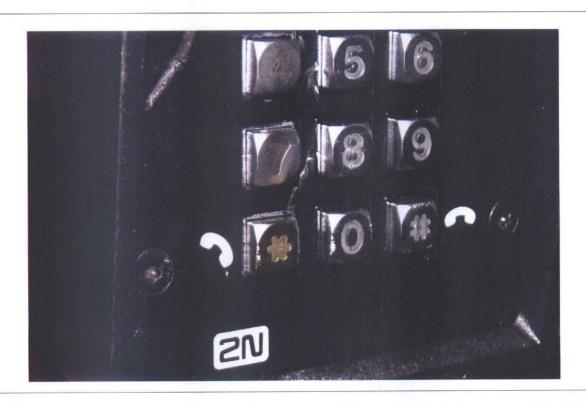
Fig. 10 - button "*" on the numeric keyboard of intercom 2N® Helios IP Force 9151102CRW after test 6

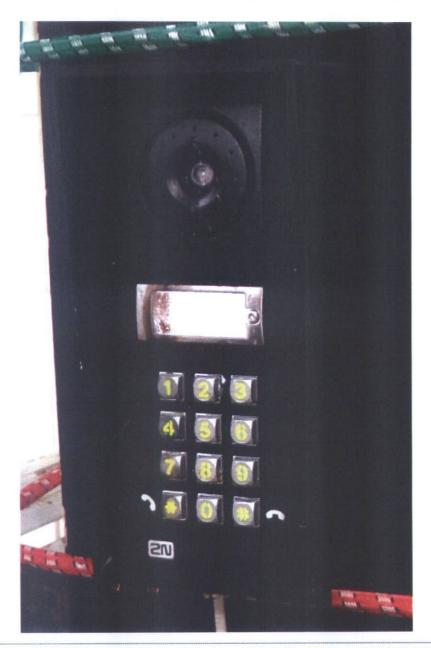
Fig. 11 - functional backlight of all buttons of intercom 2N® Helios IP Force 9151102CRW after testing

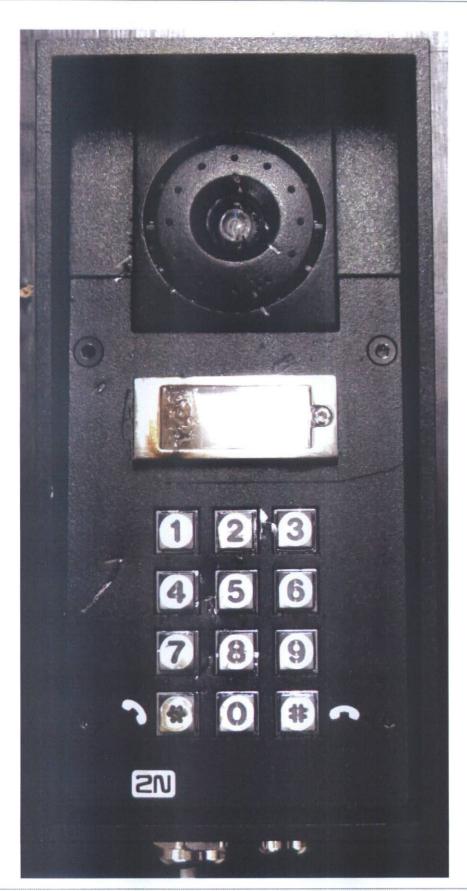
After testing, the intercom is functional.

Fig. 12 - intercom 2N® Helios IP Force 9151102CRW after testing

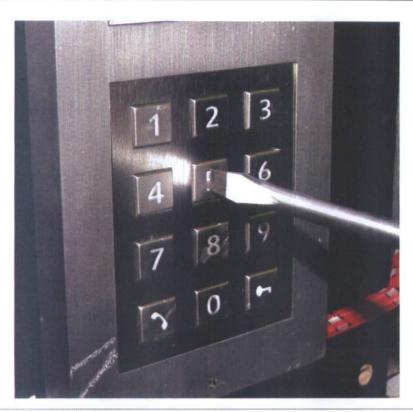
Fig. 13 - test 4 of intercom 2N® Helios IP Verso 9155101C

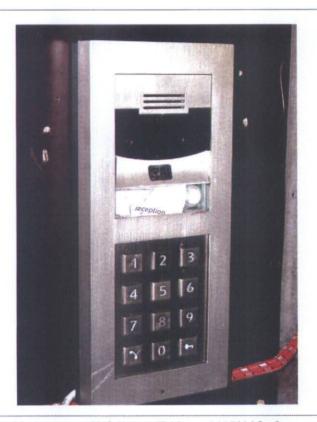
Fig. 14 - intercom 2N® Helios IP Verso 9155101C after test 5

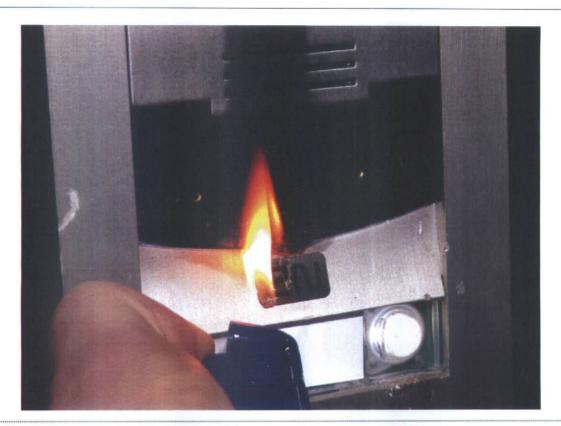
Fig. 15 - test 6 of intercom 2N® Helios IP Verso 9155101C

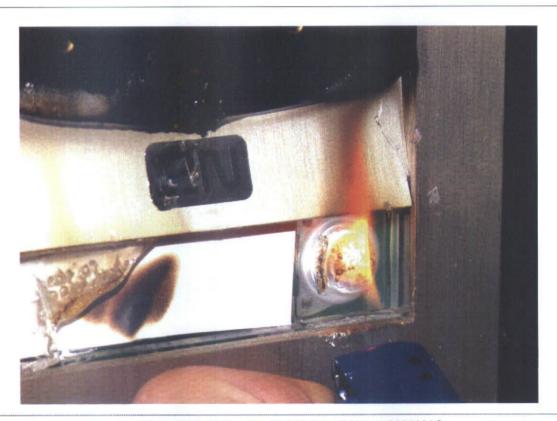
Fig. 16 - test 6 of intercom 2N® Helios IP Verso 9155101C

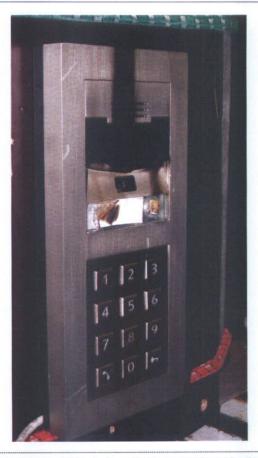
Fig. 17 - intercom 2N® Helios IP Verso 9155101C after test 6

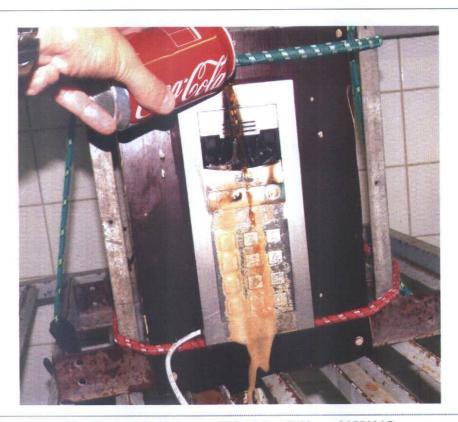
Fig. 18 - test 7 of intercom 2N® Helios IP Verso 9155101C

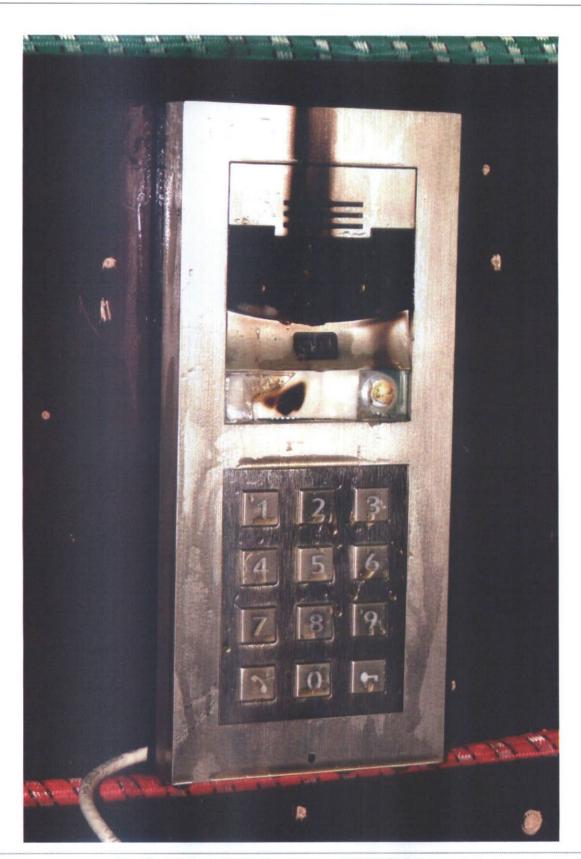
After testing, the intercom is functional.

Fig. 19 - intercom 2N® Helios IP Verso 9155101C after testing

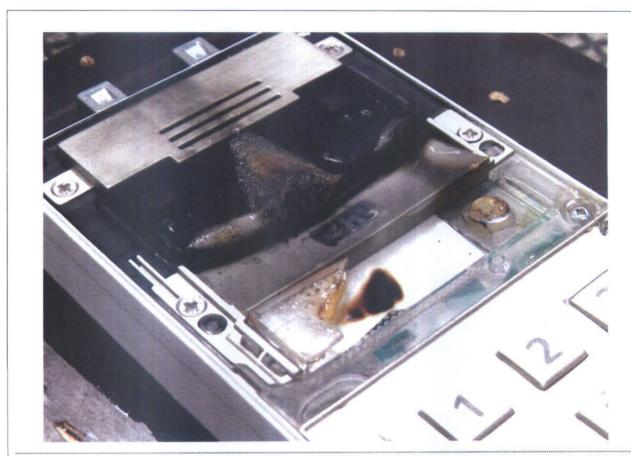
Fig. 20 - intercom 2N® Helios IP Verso 9155101C after testing

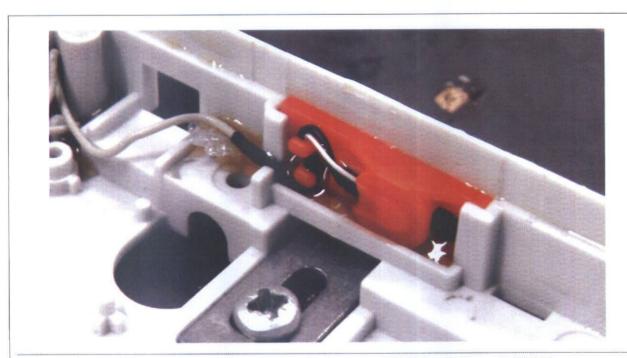
- test 1 the screws could not be unscrewed
- test 2 N/A
- test 3 the bell button cover was wrenched (the button was still functional after the test), no button of the numeric keyboard was pulled or wrenched
- test 4 no button was jammed
- test 5 the cover of the camera was not broken (the camera is still functional after the test), the enclosure surface was scratched, no button of the numeric keyboard was damaged (the buttons are still functional after the test)
- test 6 the bell button and the paper label were partially scorched (the button itself is still functional after the test), no afterflame of any plastic part occurred, no button backlight was damaged
- test 7 small amount of the drink penetrated into the intercom enclosure, the intercom function is not immediately disrupted

Fig. 21 - penetration of the drink in the intercom 2N® Helios IP Verso 9155101C

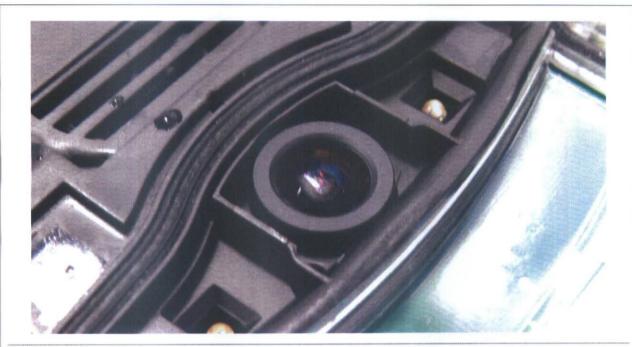
Fig. 22 - undamaged camera of intercom 2N® Helios IP Verso 9155101C
